Environmental Consequences Related to Poor Adherence to Standard Mining Practices by Artisanal and Small Scale Miners: The Case of Ashiraq Mines, Tanzania

Meserecordias W. J. Lema

College of Earth Sciences, University of Dodoma, Dodoma, Tanzania

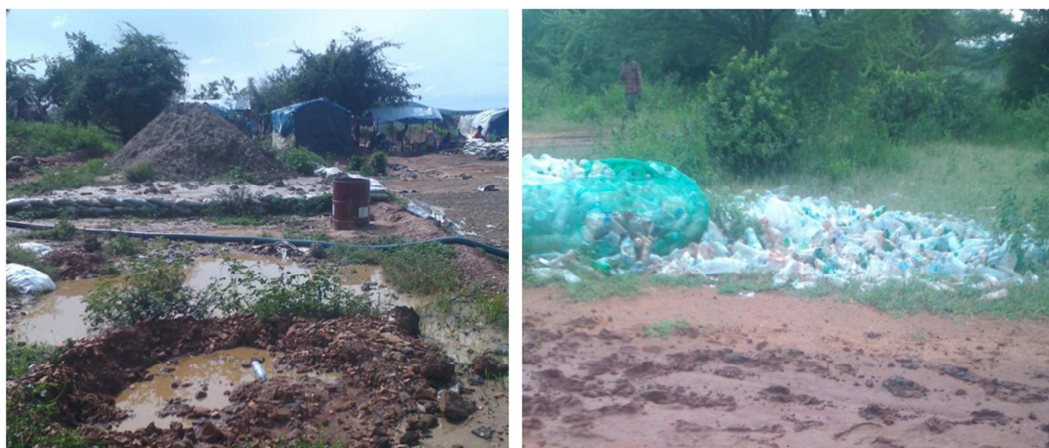
Significant land disturbance was observed at Ashiraq Mines due to SSM activities. This was associated with poor adherence to standard mining practices by ASSM. For instance, indiscriminate dumping of various types of wastes (including waste rocks, metallic and non-metallic used items i.e. plastic bags) within the mining concessions was observed (Figure 3). Infact, there were 20 different locations in which uncontrolled waste dumping was taking place, contrary to the standard mining practices stipulated under part II of the Mining (Environmental Protection for Small Scale Mining) Regulations, 2010.

Fig. 3. Improper dumping of waste materials at Ashiraq SSM.

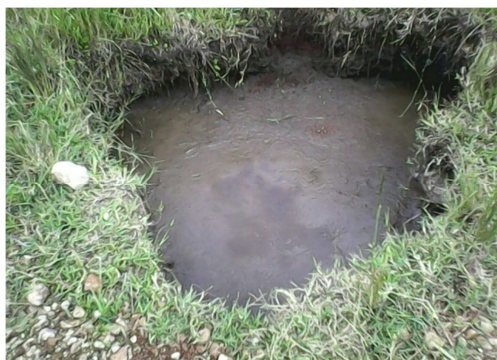
Furthermore, 6 non-backfilled abandoned shafts and 10 shallow abandoned openings were found in the licensed area. The existence of non-backfilled abandoned shaft (Figure 4) is an indication of lack of adherence to standard mining practices as stipulated under regulation 13, part IV of the Mining (Environmental Protection for Small Scale Mining) Regulations, 2010 that requires backfilling and re-vegetating or fencing of the abandoned previous workings before commencing development of a new working. Shallow abandoned openings are caused by poor or guesswork approach during mineral exploration activities by ASSM.

Fig. 4. Abandoned opening at Ashiraq SSM.

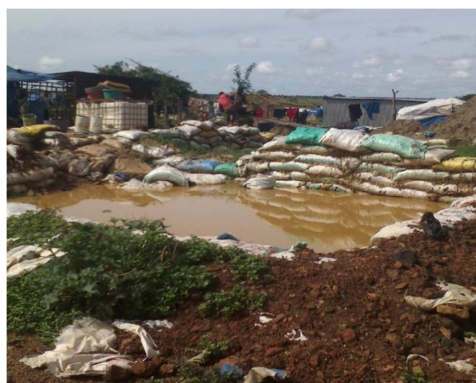
Not only that, but also 8 improperly constructed tailings dumps were observed in the license area. Figure 5 shows one of the existing tailings dam which is poorly constructed without proper linings, causing a threat towards leaching of waste water and other dangerous contaminants that may cause detrimental effect to the surrounding environment. This is against standard mining practices, stipulated under regulation 14 of the Mining (Environmental Protection for Small Scale Mining) Regulations, 2010 under part IV, that requires a holder of a primary mining license to ensure that tailings are disposed of at a proper place in a manner approved by the inspector.

Fig. 5. Poorly constructed tailings dam at Ashiraq SSM.
